Manhole Inspection Summary

Manhole # S31E__022MH

Insp Date: **8/4/08 2:40 PM**

Location Address: **518 w fayette st**

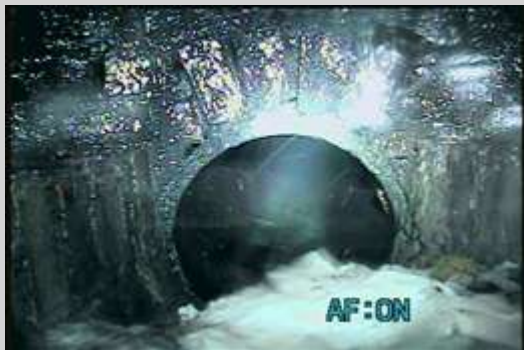
12 O'Clock Outflow

10 in. Circular Gravity Sewer
Pipe Out @ 12 O'Clock

Invert Depth: 12.83 (ft.) Flow Characteristics: Fast

Deposits: ☒ None ☐ Mud ☐ Sludge ☐ Debris ☐ Grease

Infiltration: None Pipe Seal Cond: Unknown

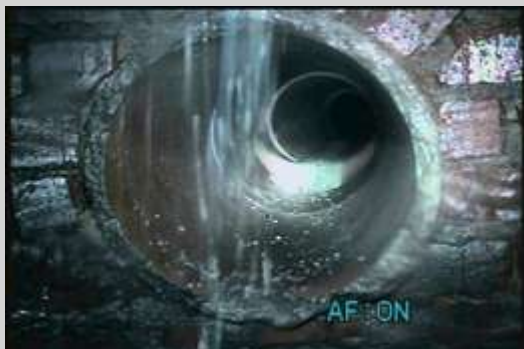
3 O'Clock Inflow

10 in. Circular Gravity Sewer
Pipe In @ 3 O'Clock

Invert Depth: 10.33 (ft.) Flow Characteristics: Slow

Infiltration: None Pipe Seal Cond: Unknown

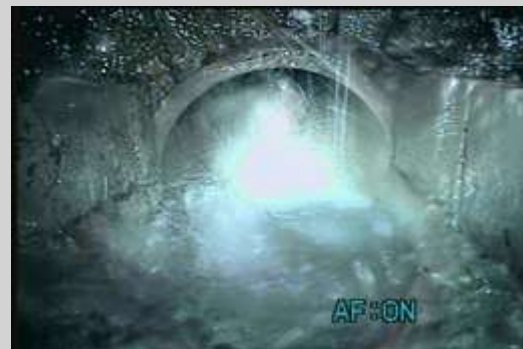
Drop In @ 3 O'Clock

Drop: Outside Direct

Inv Depth: 12.50 (ft.)

Drop Condition: Open

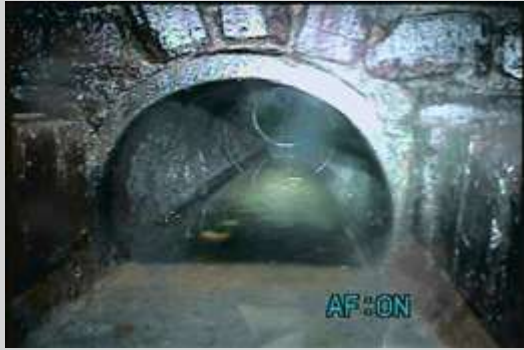
6 O'Clock Inflow

10 in. Circular Gravity Sewer
Pipe In @ 6 O'Clock

Infiltration: **None** Pipe Seal Cond: **Unknown**
